PRELIMINARY GEOTECHNICAL EVALUATION

Mill Creek Drive and Ridge Route Drive Laguna Hills, California

18 February 2026 (revised)
700128701

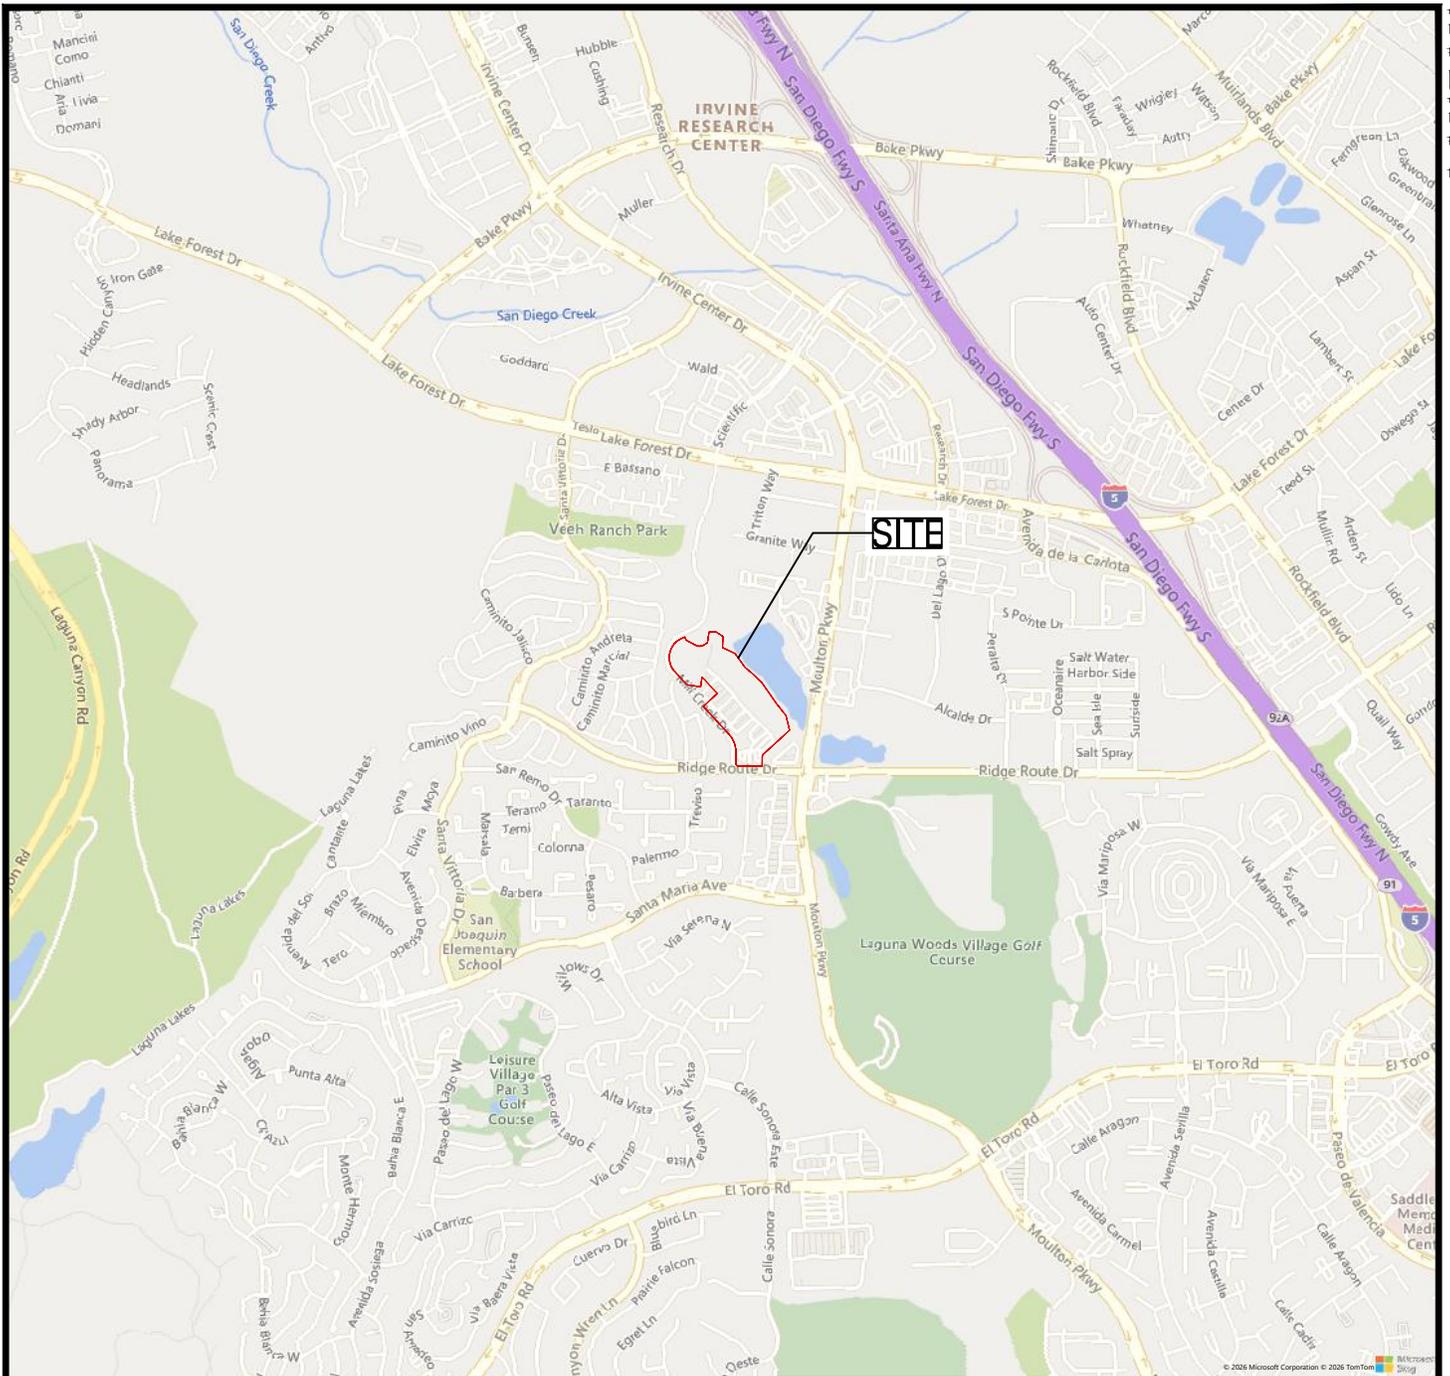
— SITE LIMITS

<p>LANGAN Langan CA, Inc. 18575 Jamboree Road, Suite 150 Irvine, CA 92612 T: 949.561.9200 F: 949.561.9201 www.langan.com</p>	<p>Project</p> <p>PROJECT HERE MILL CREEK DRIVE AND RIDGE ROUTE DRIVE</p> <p>LAGUNA HILLS</p> <p>ORANGE COUNTY CALIFORNIA</p>	<p>Figure Title</p> <p>SITE LOCATION MAP</p>	<p>Project No.</p> <p>700128701</p>	<p>Figure No.</p> <p>1</p>	
			<p>Date</p> <p>FEBRUARY 2026</p>		
			<p>Scale</p> <p>AS SHOWN</p>		
			<p>Drawn By</p> <p>JX</p>

The proposed development is located at the northeast corner of Mill Creek Drive and Ridge Route Drive in Laguna Hills, CA. The approximately 18½-acre site is on Orange County Assessor Tax Number (APNs) 588-161-06 to 588-161-10, 588-161-12, 588-161-13, 588-141-11, and 588-141-12. The site is bound by Mill Creek Drive to the west, Ridge Route Drive to the south, the lower portion of the downhill slope to the Veeh Reservoir to the northeast, and existing development to the north as shown on Figure 1, Site Location Map.

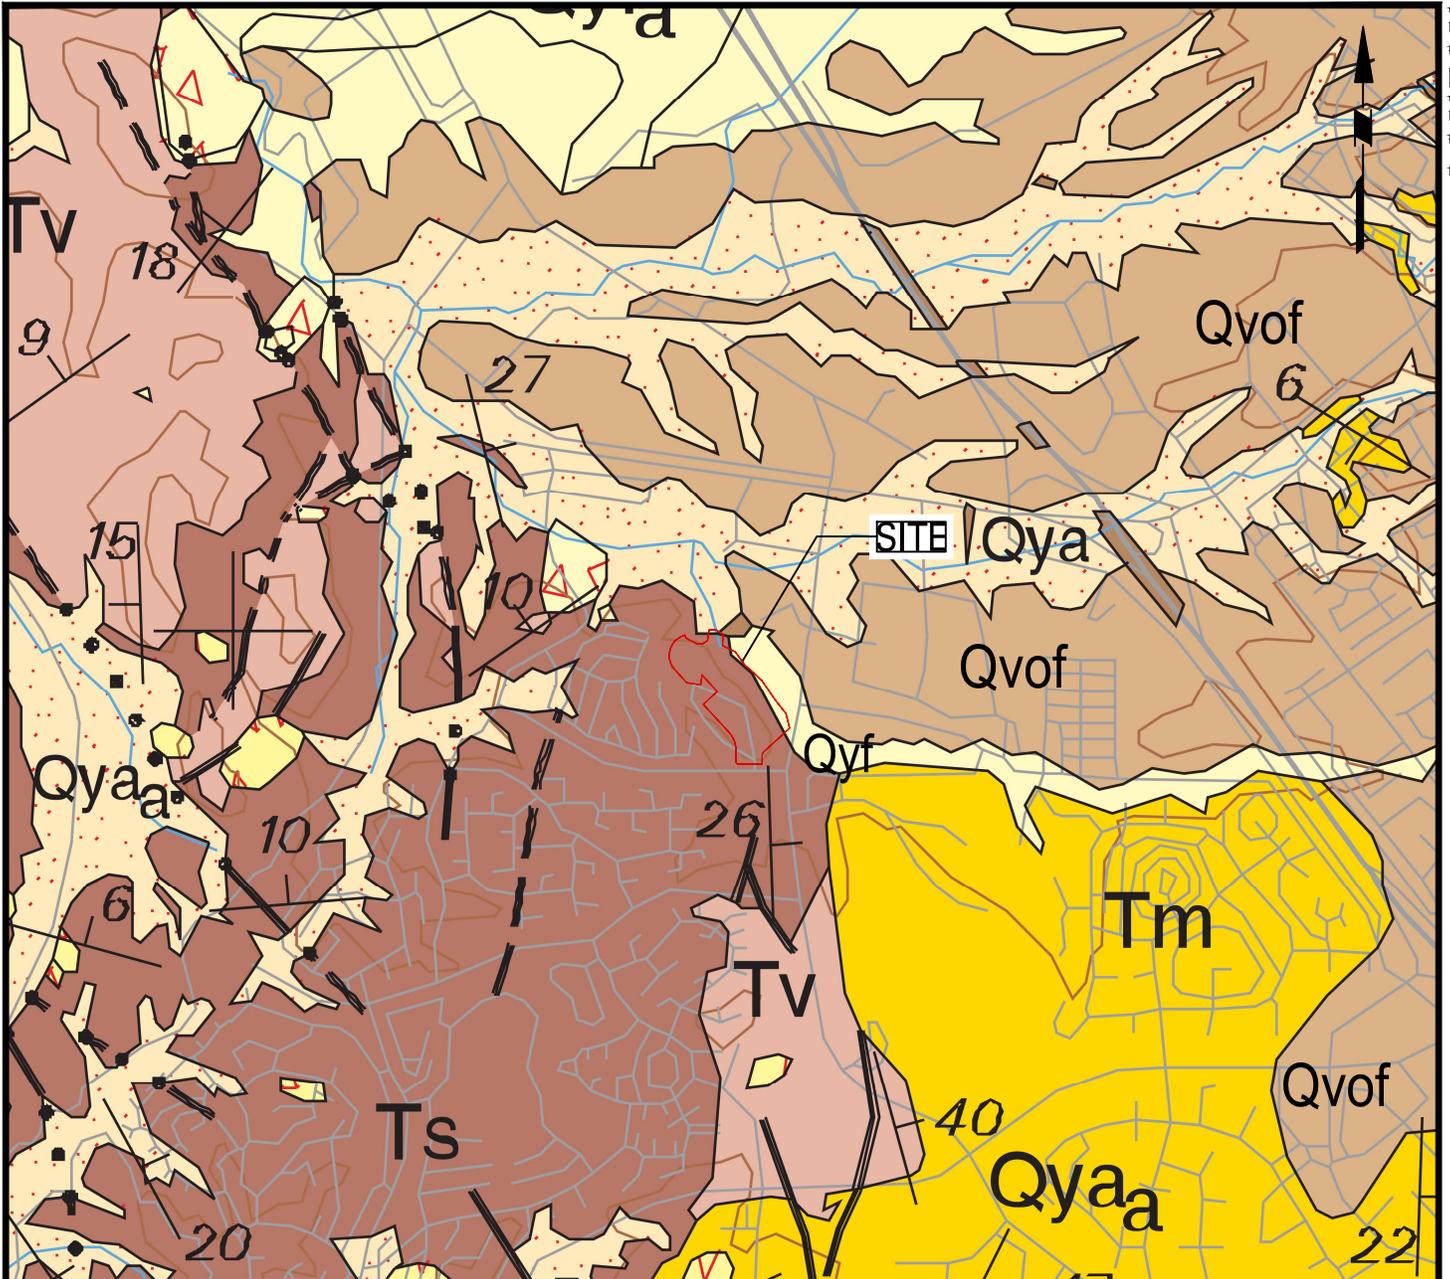
- SITE LIMITS
- Qya YOUNG AXIAL-CHANNEL DEPOSITS
- Qyf YOUNG ALLUVIAL FAN DEPOSITS
- Qvof VERY OLD ALLUVIAL FAN DEPOSITS
- Tm MONTEREY FORMATION
- Tv VAQUEROS FORMATION
- Ts SESPE FORMATION
- BEDROCK (INACTIVE) FAULT - SOLID WHERE ACCURATELY LOCATED, DASHED WHERE APPROXIMATELY LOCATED OR INFERRED; DOTTED WHERE CONCEALED
- STRIKE AND DIP OF BEDS - INCLINED

REFERENCE: GEOLOGIC MAP OF THE SAN BERNARDINO AND SANTA ANA 30' X 60' QUADRANGLES, CALIFORNIA, D.M. MORTON AND F.K. MILLER (2006).

<p style="font-size: small;">Langan CA, Inc.</p> <p style="font-size: x-small;">18575 Jamboree Road, Suite 150 Irvine, CA 92612</p> <p style="font-size: x-small;">T: 949.561.9200 F: 949.561.9201 www.langan.com</p>	<p>Project</p> <p>PROJECT HERE</p> <p>MILL CREEK DRIVE AND RIDGE ROUTE DRIVE</p> <p>LAGUNA HILLS</p> <p>ORANGE COUNTY CALIFORNIA</p>	<p>Figure Title</p> <p>REGIONAL GEOLOGIC MAP</p>	<p>Project No.</p> <p>700128701</p> <p>Date</p> <p>FEBRUARY 2026</p> <p>Scale</p> <p>AS SHOWN</p> <p>Drawn By</p> <p>JX</p>
			2

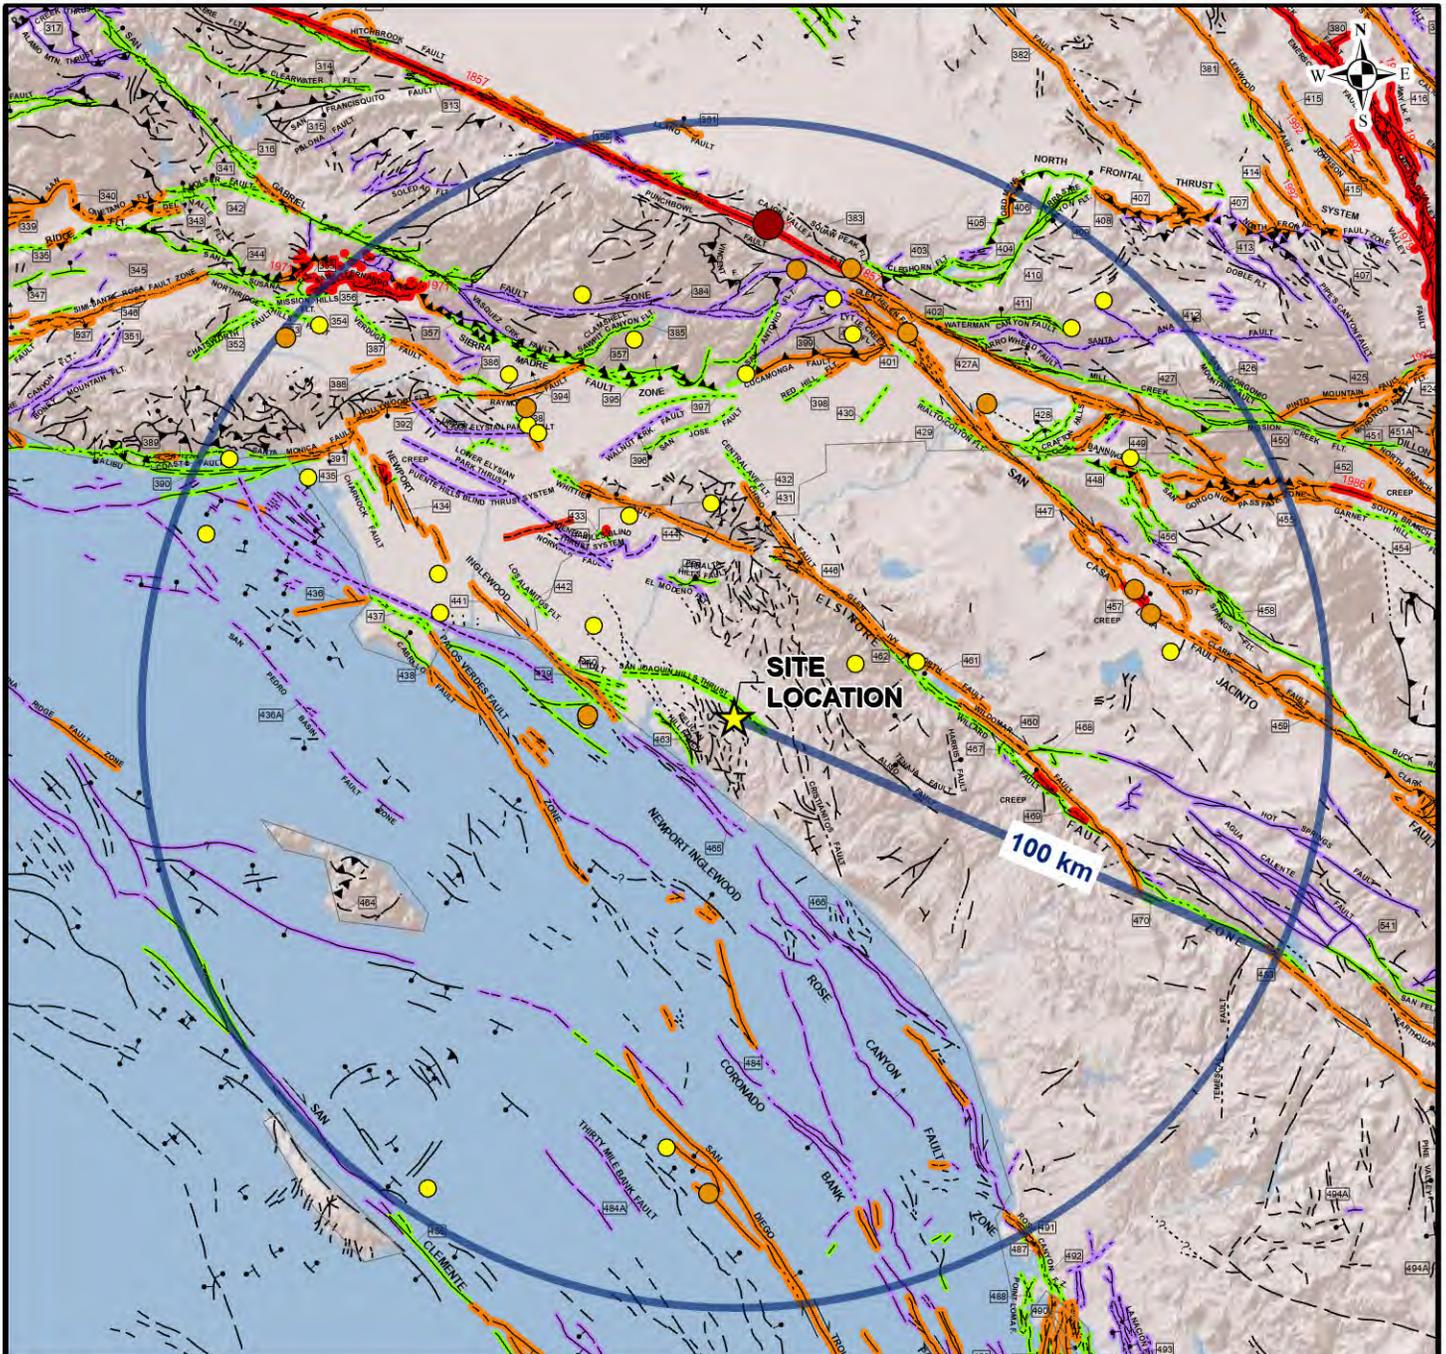
1. Base figure reproduced from Jennings, C.W., and Bryant, W.A., 2010, Fault activity map of California: California Geological Survey Geologic Data Map No. 6, map scale 1:750,000.

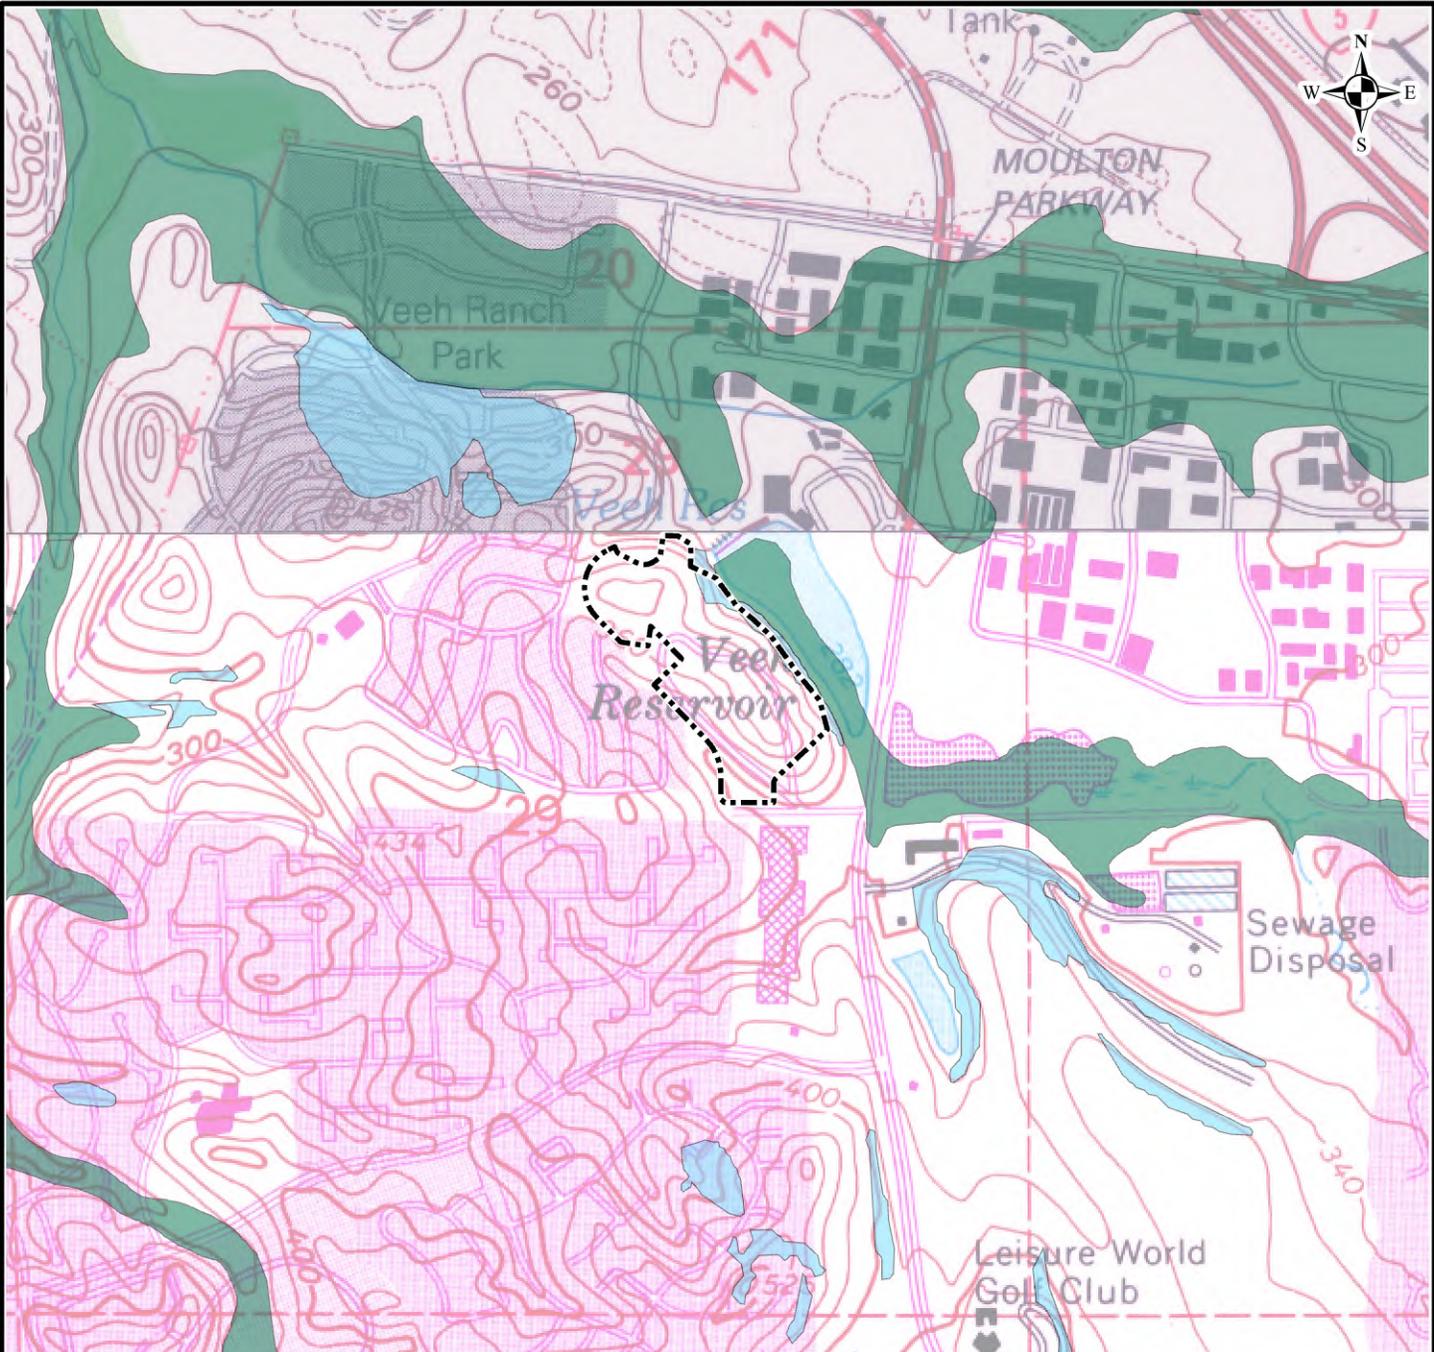
Liquefaction Zone
 Areas where historical occurrence of liquefaction, or local geological, geotechnical and ground water conditions indicate a potential for permanent ground displacements such that mitigation as defined in Public Resources Code Section 2693(c) would be required

Landslide Zone
 Areas where previous occurrence of landslide movement, or local topographic, geological, geotechnical and subsurface water conditions indicate a potential for permanent ground displacements such that mitigation as defined in Public Resources Code Section 2693(c) would be required.

<p>LANGAN Langan CA, Inc. 18575 Jamboree Road, Suite 150 Irvine, CA 92612 T: 949.561.9200 F: 949.561.9201 www.langan.com</p>	<p>Project PROJECT HERE MILL CREEK DRIVE AND RIDGE ROUTE DRIVE LAGUNA HILLS ORANGE COUNTY CALIFORNIA</p>	<p>Figure Title SEISMIC HAZARD ZONES MAP</p>	<p>Project No. 700128701 Date FEBRUARY 2026 Scale 1" = 1,000' Drawn By OG Figure 4</p>
---	--	---	--

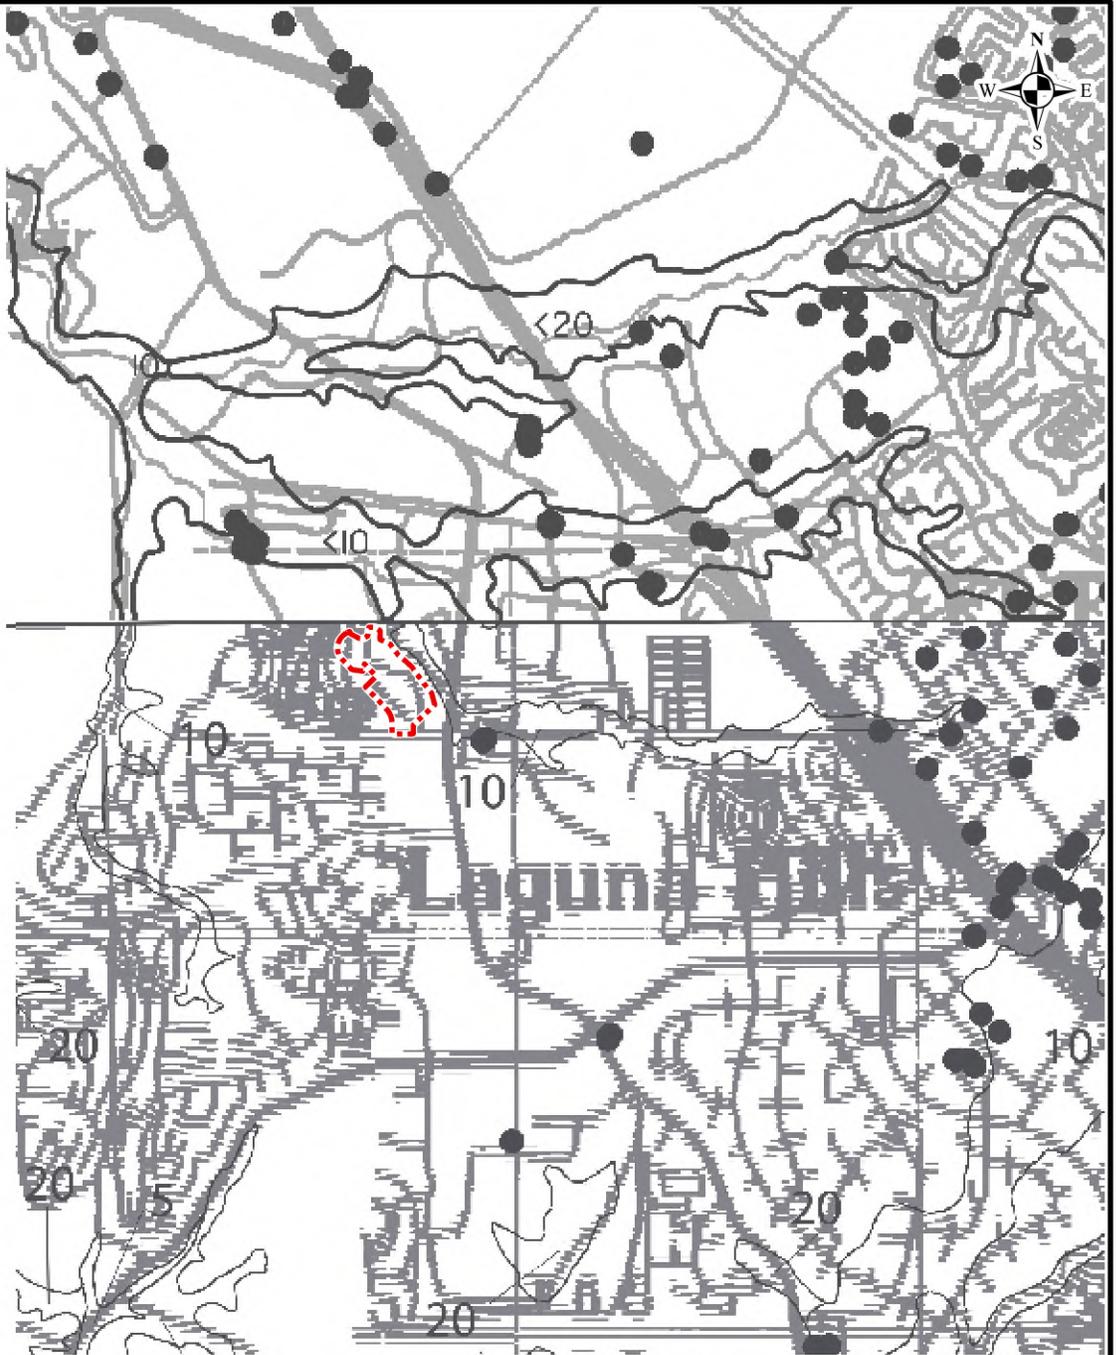
Notes:
 1. Seismic Hazard Zone Reports for San Juan Capistrano Plate and Lake Forest (El Toro) Plate provided by California Department of Conservation Division of Mines and Geology.
 2. All features shown are approximate.

<p>LANGAN</p> <p>Langan CA, Inc.</p> <p>18575 Jamboree Road, Suite 150 Irvine, CA 92612</p> <p>T: 949.561.9200 F: 949.561.9201 www.langan.com</p>	<p>Project</p> <p>PROJECT HERE</p> <p>MILL CREEK DRIVE AND RIDGE ROUTE DRIVE</p> <p>LAGUNA HILLS</p> <p>ORANGE COUNTY CALIFORNIA</p>	<p>Figure Title</p> <p>HISTORICAL HIGH GROUNDWATER MAP</p>	<p>Project No. 700128701</p> <p>Date FEBRUARY 2026</p> <p>Scale 1" = 2,500'</p> <p>Drawn By OG</p> <p>Figure 5</p>
--	---	---	---

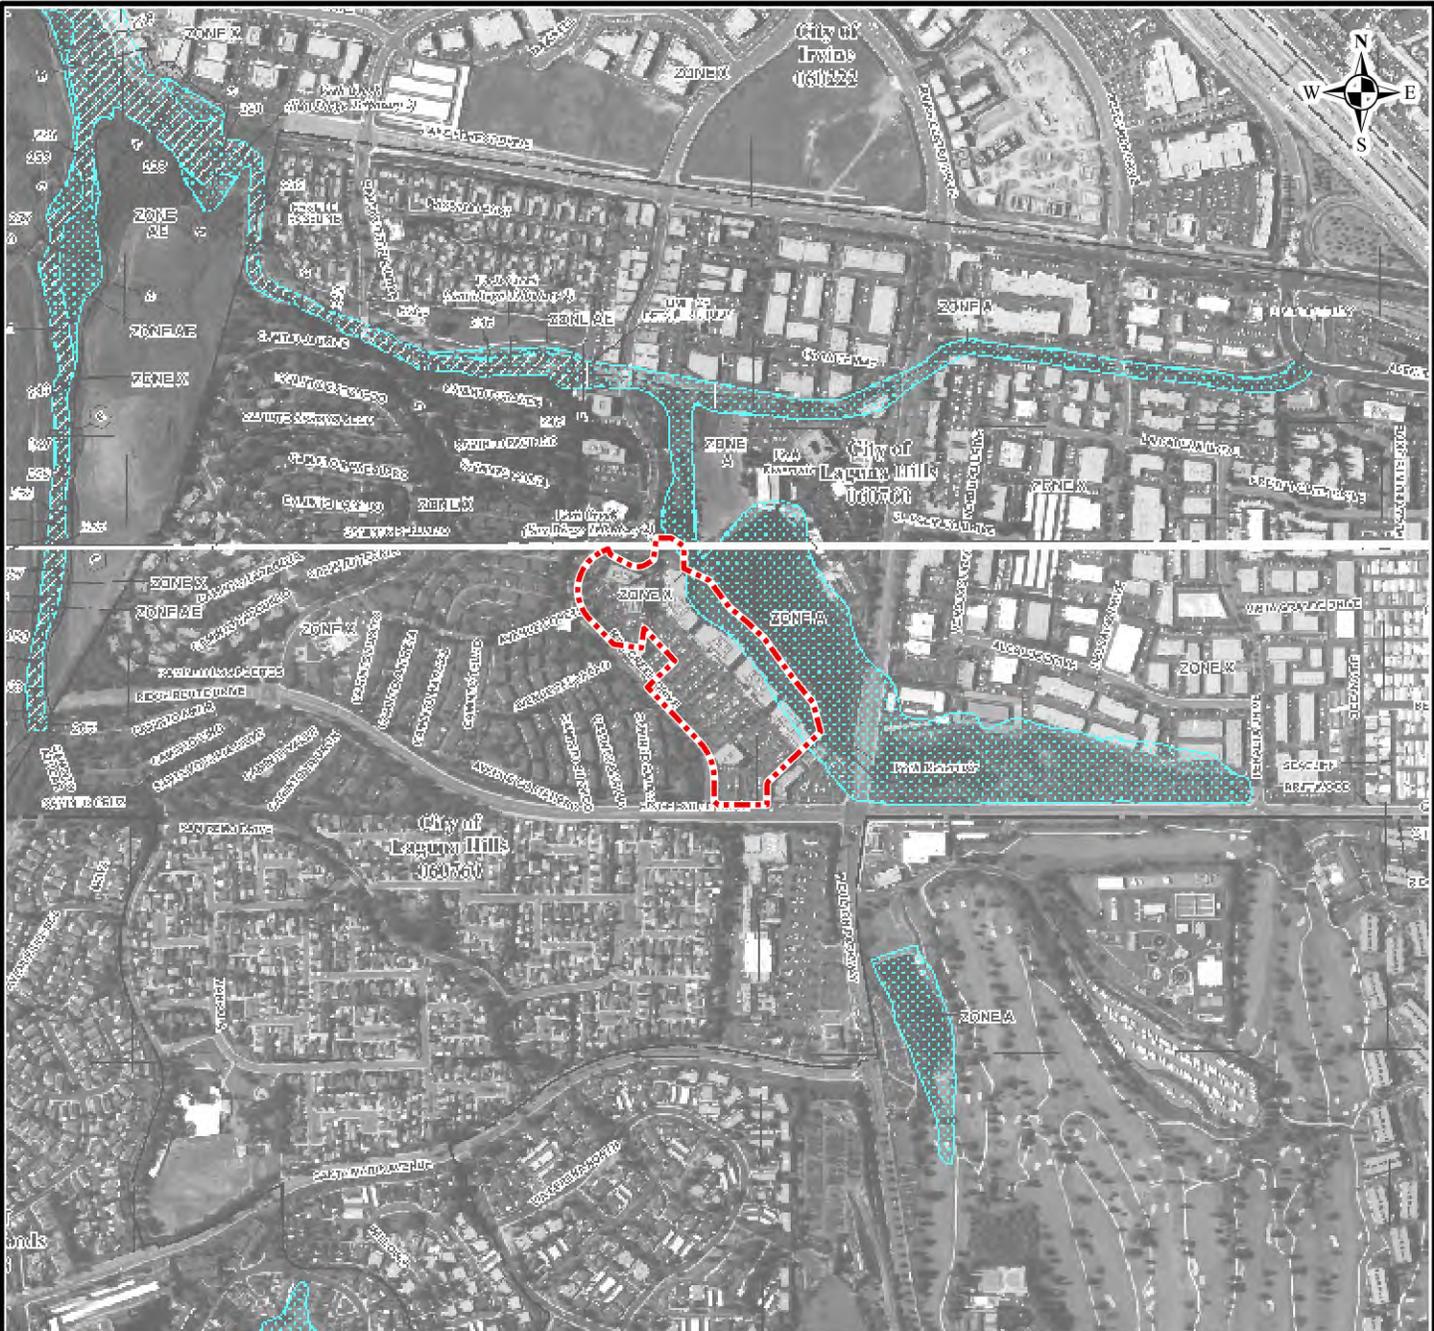
Project No.
 700128701
 Date
 FEBRUARY 2026
 Scale
 1" = 1,000'
 Drawn By
 OG
 Figure
6

- SPECIAL FLOOD HAZARD AREAS SUBJECT TO INUNDATION BY THE 1% ANNUAL CHANCE FLOOD
- 1% annual chance floodplain boundary
- 0.2% annual chance floodplain boundary
- Floodway boundary
- Zone D boundary
- CBRS and OPA boundary
- Boundary dividing Special Flood Hazard Area Zones and boundary dividing Special Flood Hazard Areas of different Base Flood Elevations, flood depths or flood velocities.
- ZONE A No Base Flood Elevations determined.
- ZONE AE Base Flood Elevations determined.
- OTHER FLOOD AREAS
- ZONE X Areas of 0.2% annual chance flood; areas of 1% annual chance flood with average depths of less than 1 foot or with drainage areas less than 1 square mile; and areas protected by levees from 1% annual chance flood.
- OTHER AREAS
- ZONE X Areas determined to be outside the 0.2% annual chance floodplain.

Figure Title
**FEMA FLOOD
 MAP**

A review of the FEMA National Flood Hazard Layer, FIRM Panel 060590426J (2009) indicates that the northeast portion of the Site along the slope to the reservoir is located within Zone A, defined as a having a "1% Annual Chance Flood Hazard" without base flood elevation, and the southwest portion of the Site is located within Zone X, defined as having a "0.2% Annual Chance Flood Hazard." See Figure 6 for the FEMA Flood Hazard Map. The Project Civil engineer and architect should address the potential flood hazard as part of the site design.

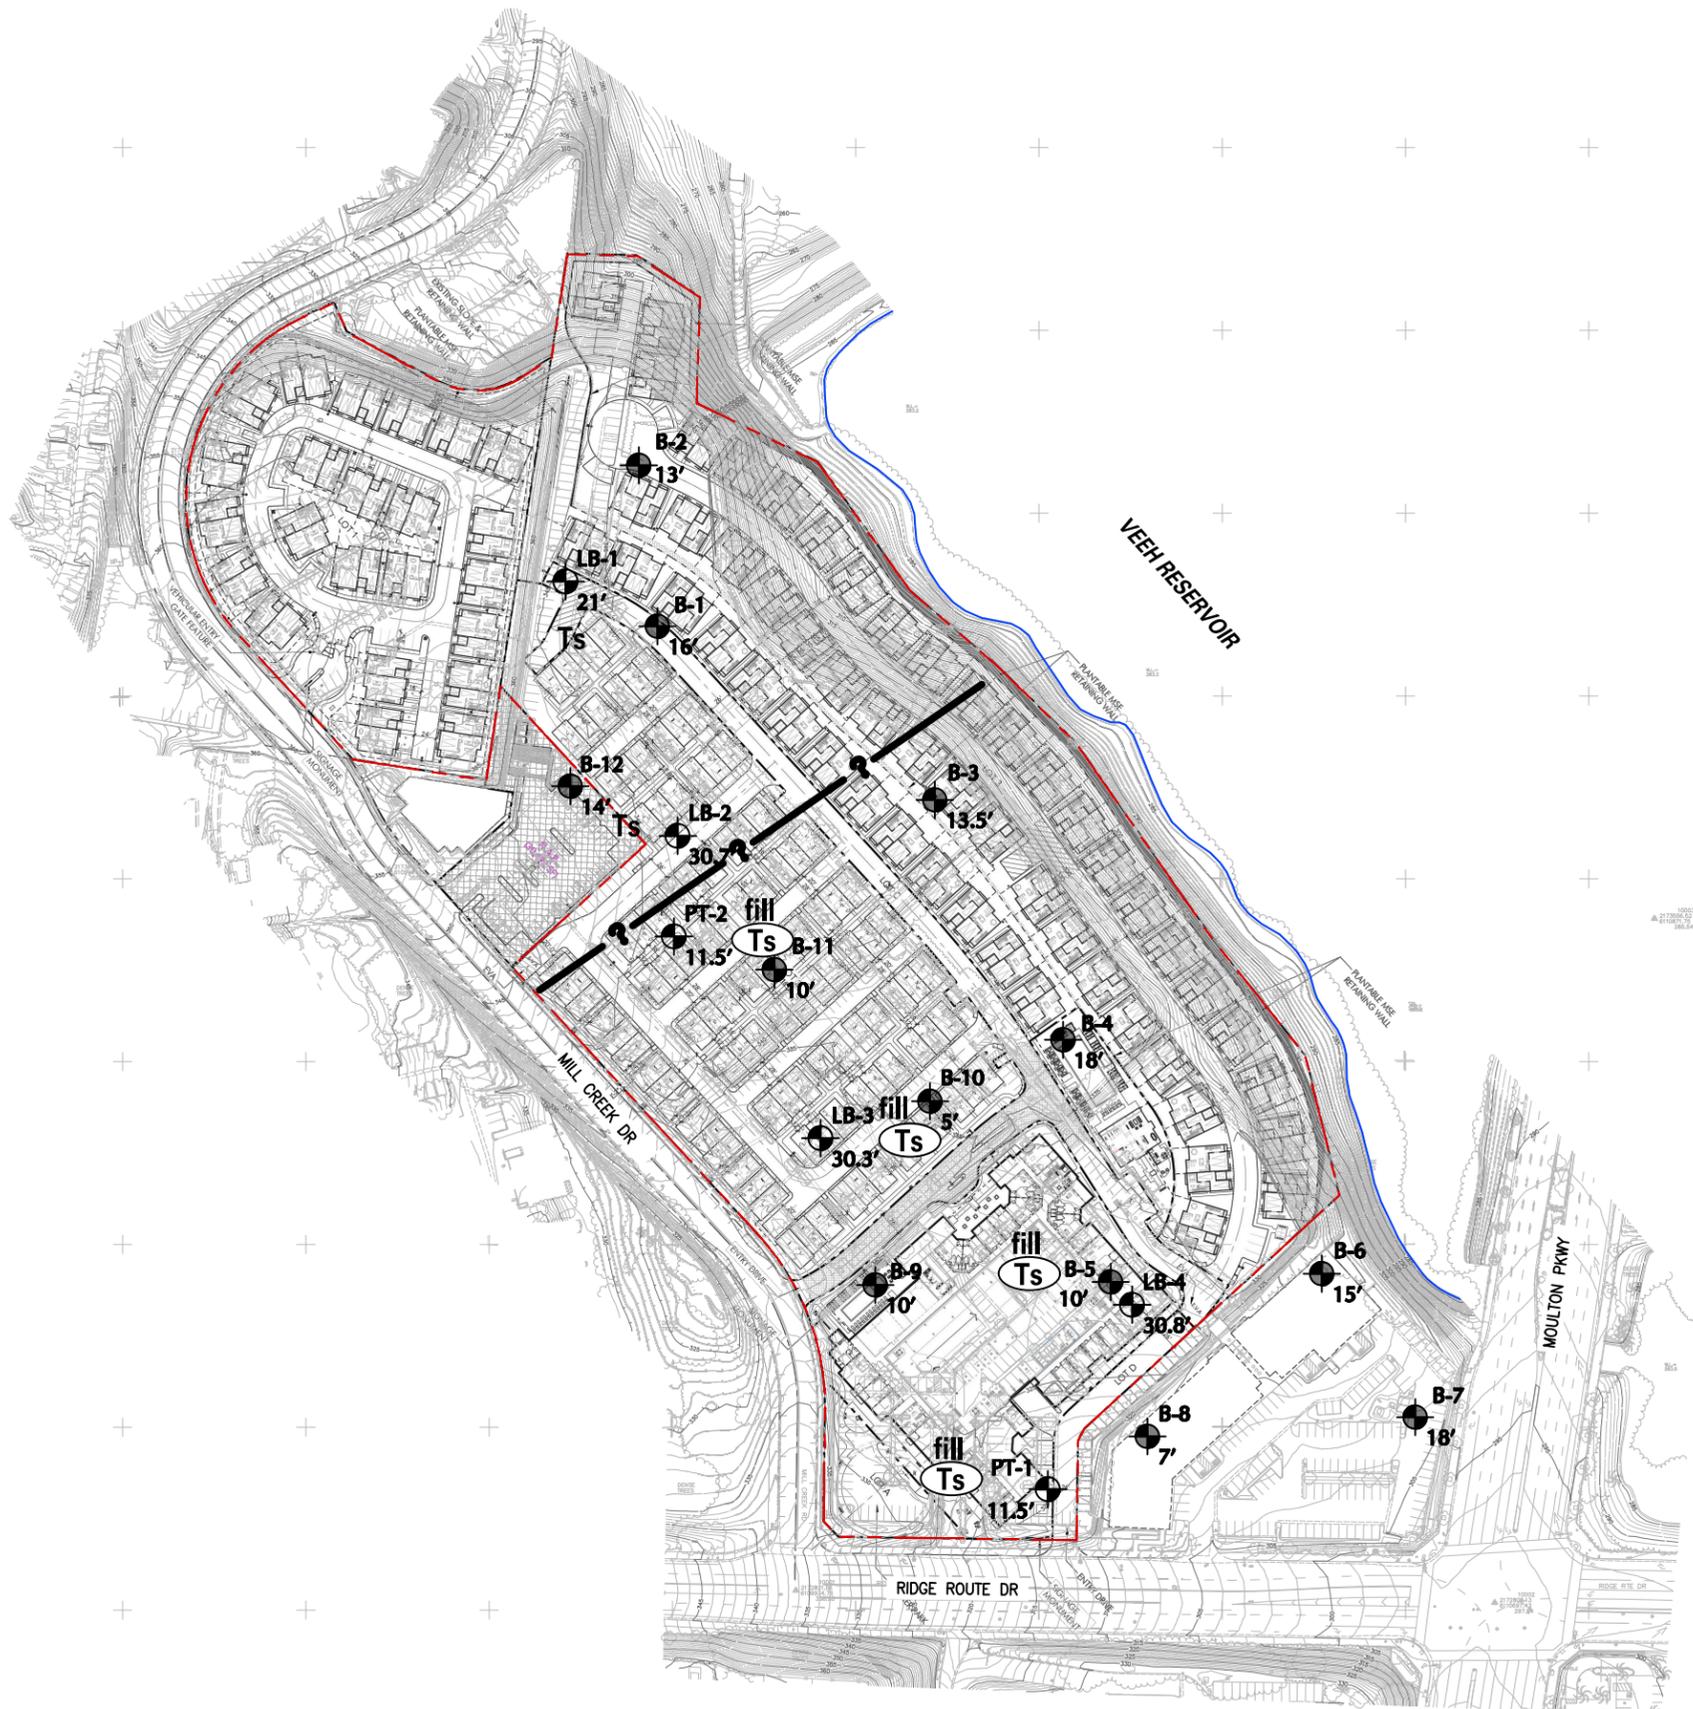
- SITE LIMITS
- WATER LINE OF VEEH RESERVOIR AT THE TIME OF THE SURVEY

- SITE PLAN BASED ON:
1. TOPOGRAPHIC AND BOUNDARY PLANS TITLED "BASEMAP OF 23272, 32382 MILL CREEK DRIVE, LAGUNA HILLS, CALIFORNIA" DATED 30 MAY 2023 FROM FUSCOE ENGINEERING.
 2. CONCEPTUAL DEVELOPMENT PLAN TITLED "OVERALL SITE PLAN, SP1" DATED 16 DECEMBER 2025 PROVIDED BY KINGSBARN REALITY CAPITAL.
 3. GEOTECHNICAL REPORT TITLED "PRELIMINARY SOILS INVESTIGATION, TENTATIVE PARCEL MAP. NO. 85-367, ORANGE COUNTY, CALIFORNIA" DATED 18 MARCH 1986 BY EJN & ASSOCIATES.

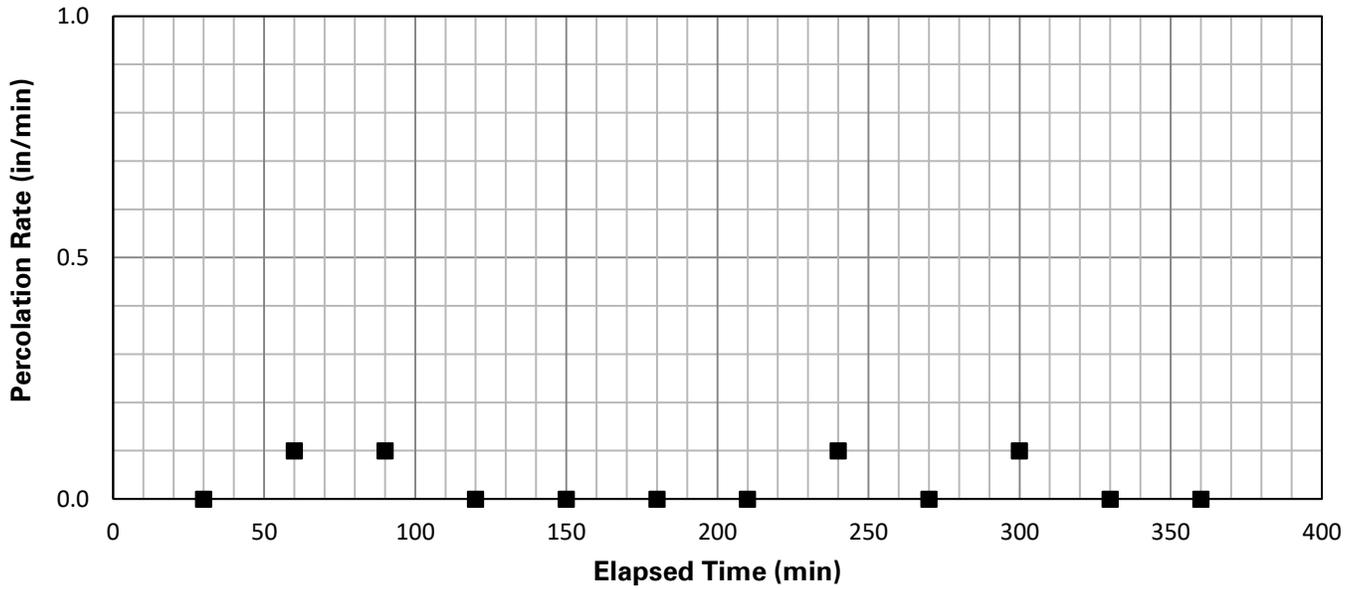
1. Percolation test PT-1 was performed approximately 10 feet below existing grade.
2. Refer to Figure 1 for percolation test location.

<small>Langan Engineering & Environmental Services, Inc. 18575 Jamboree, Suite 150 Irvine, CA 92612 P: 949.255.8640 F: 949.255.8641 www.langan.com</small>	Project	Title	Project No. 700128701
	Project HERE	PERCOLATION TEST RESULTS	Date March 2023
	Mill Creek Drive and Ridge Route Drive	PT-1	Scale N/A
	LAGUNA HILLS ORANGE COUNTY CALIFORNIA		Prepared By: RF

Boring ID	Test Depth (feet)	Soil Type	Infiltration Rate (inches/hour)
PT-1	10	CL	0.0
PT-2	10	SC	0.0

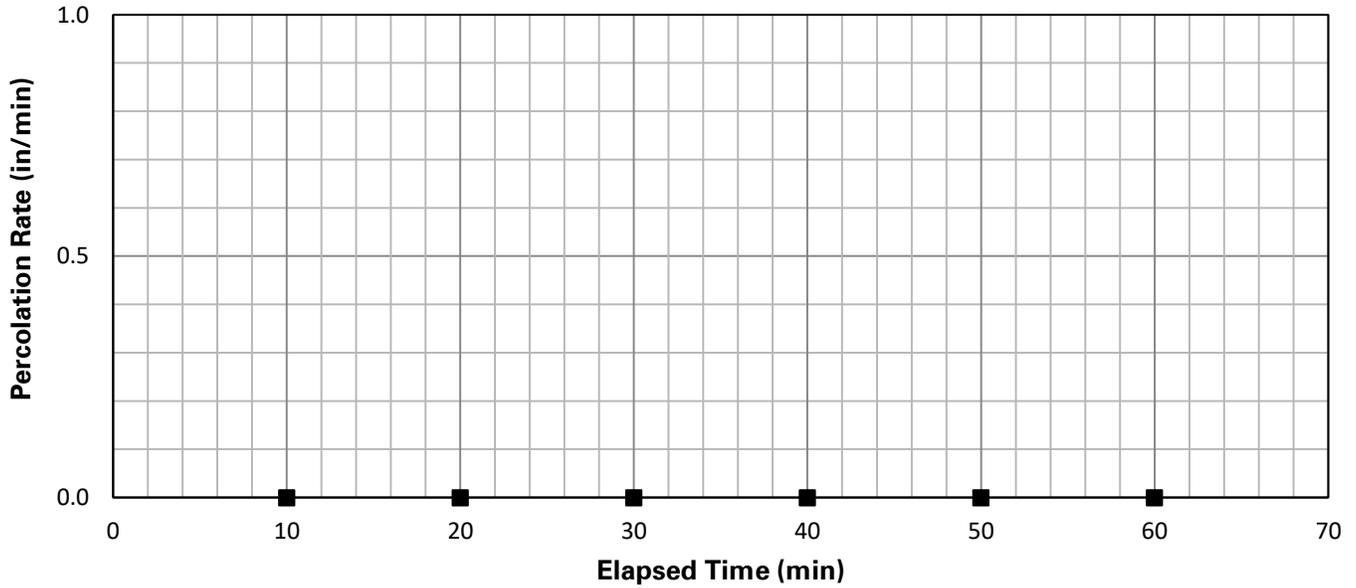
1. Percolation test PT-2 was performed approximately 10 feet below existing grade.
2. Refer to Figure 1 for percolation test location.

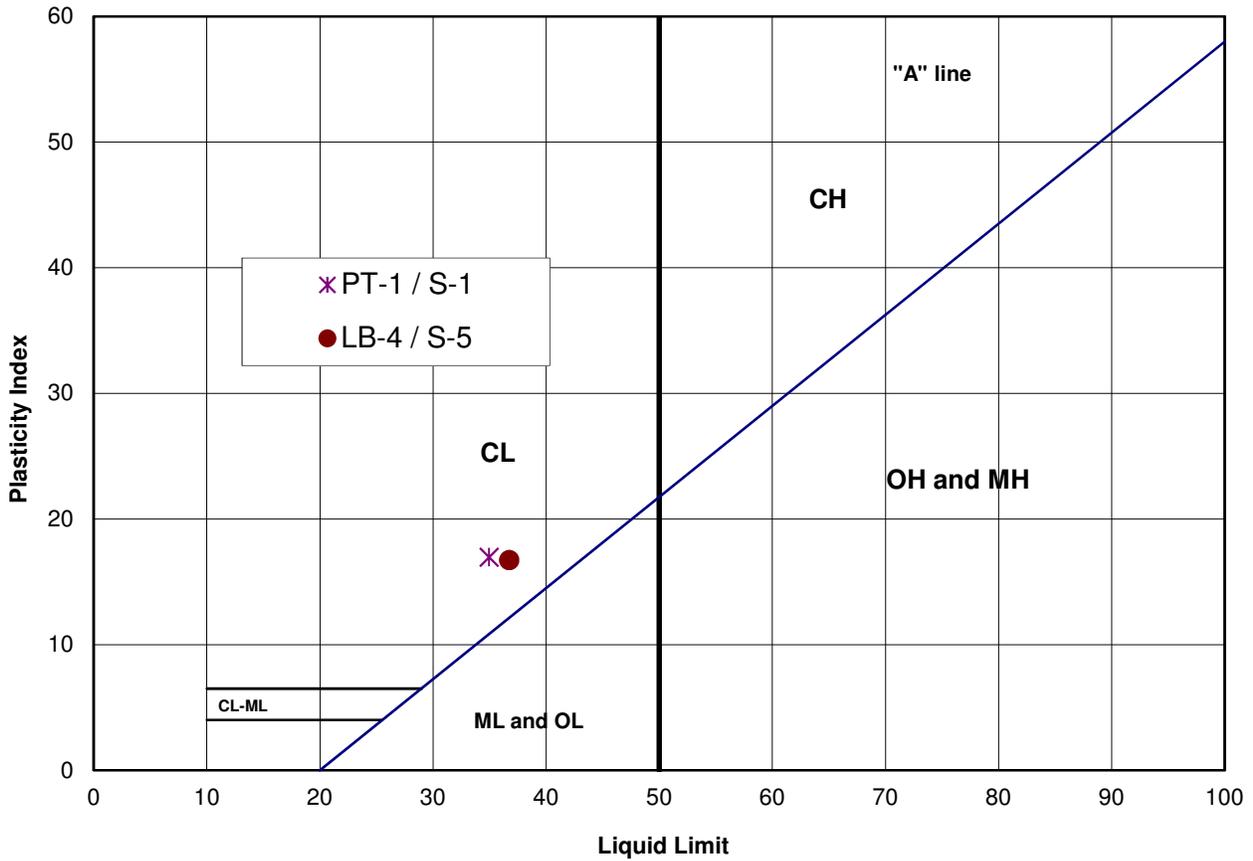
PLASTICITY INDEX _ ASTM D4318

Sample	Depth	LL	PL	PI	USCS	Material Description
PT-1 / S-1	5'	35	18	17	CL	
LB-4 / S-5	15'	37	20	17	CL

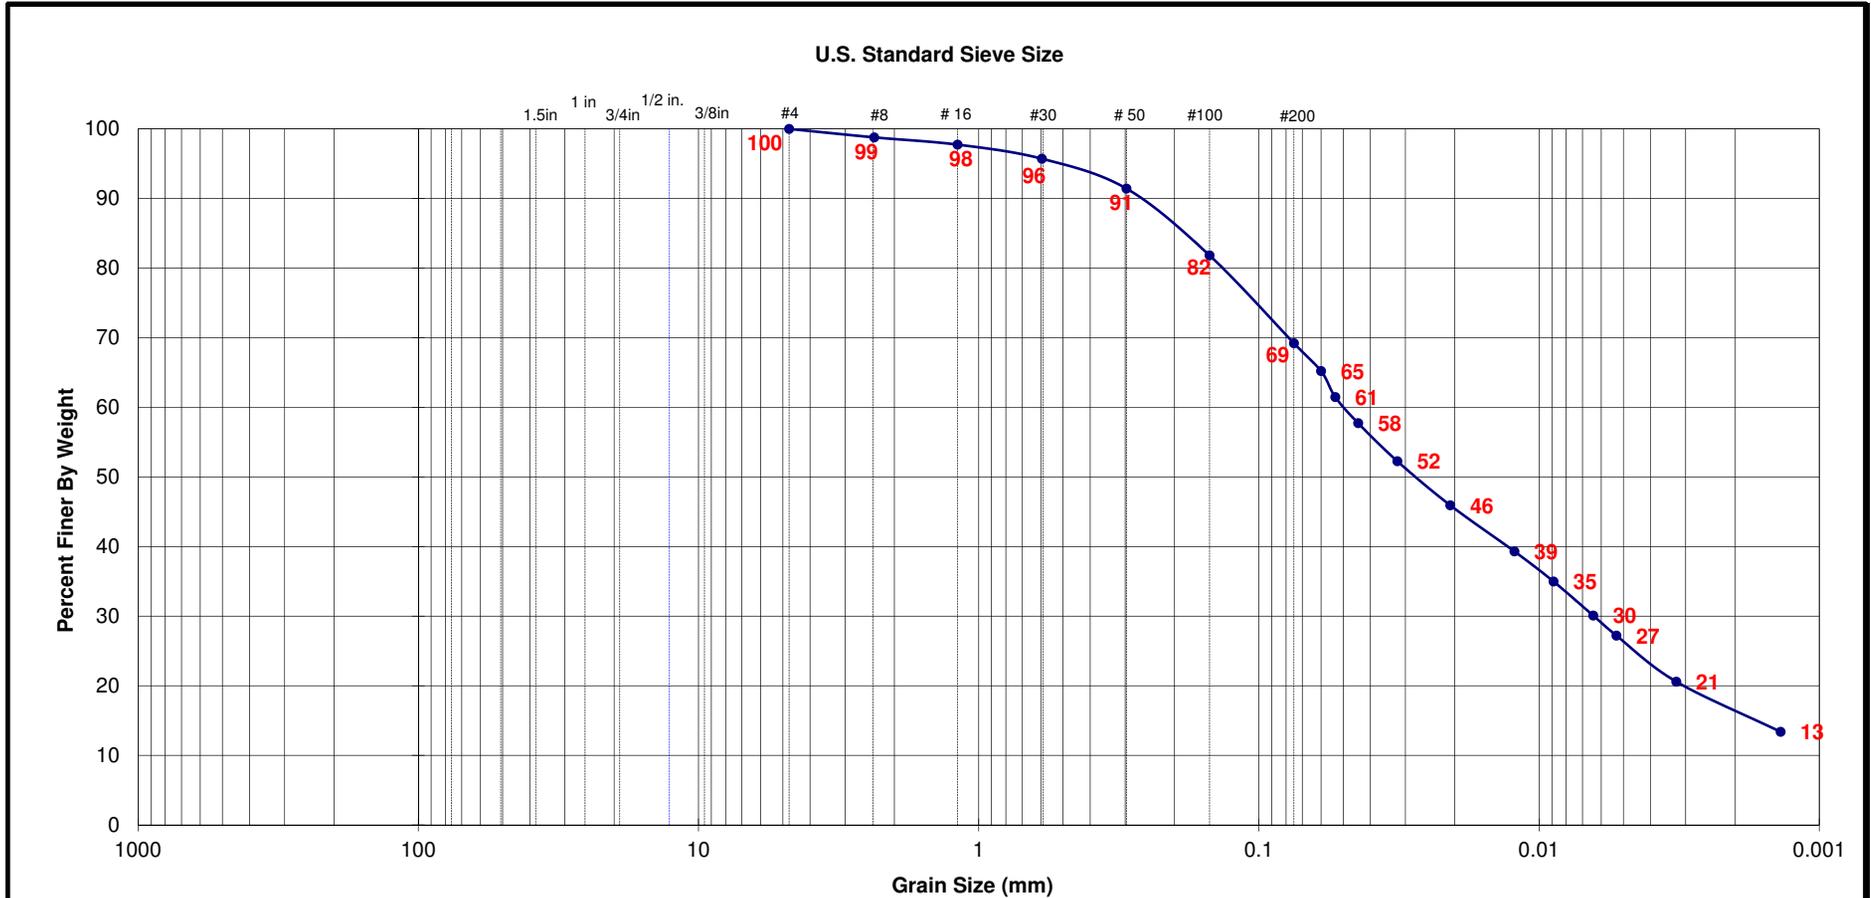
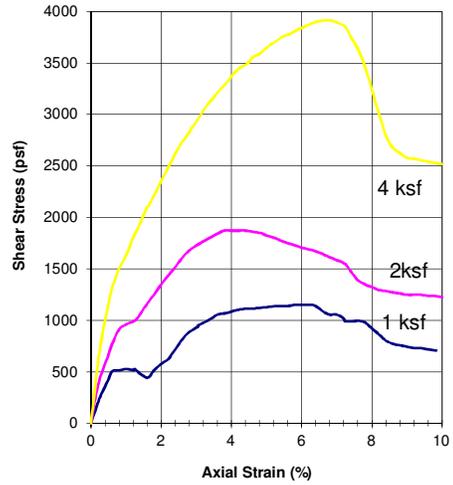
DIRECT SHEAR ASTM D3080

PROJECT: Langan # 700128701
 GLA JOB NO.: 2012-0057
 SAMPLE : LB-1 / S-1
 SAMPLE TYPE: Undisturbed
 DESCRIPTION: Clayey Sand

Specimen No.	1	2	3
Normal Stress, psf	1000	2000	4000
Peak Stress, psf	1152	1872	3912
Displacement, % strain	5.84	3.8	6.64
Ultimate Stress, psf	708	1224	2532
Displacement, % strain	10	10	10
Initial Dry Density, pcf	127.2	127.2	127.2
Initial Water Content, %	9.9	9.9	9.9
Final Water Content, %	18.0	18.0	18.0
Strain Rate, in/min.	0.0084	0.0084	0.0084

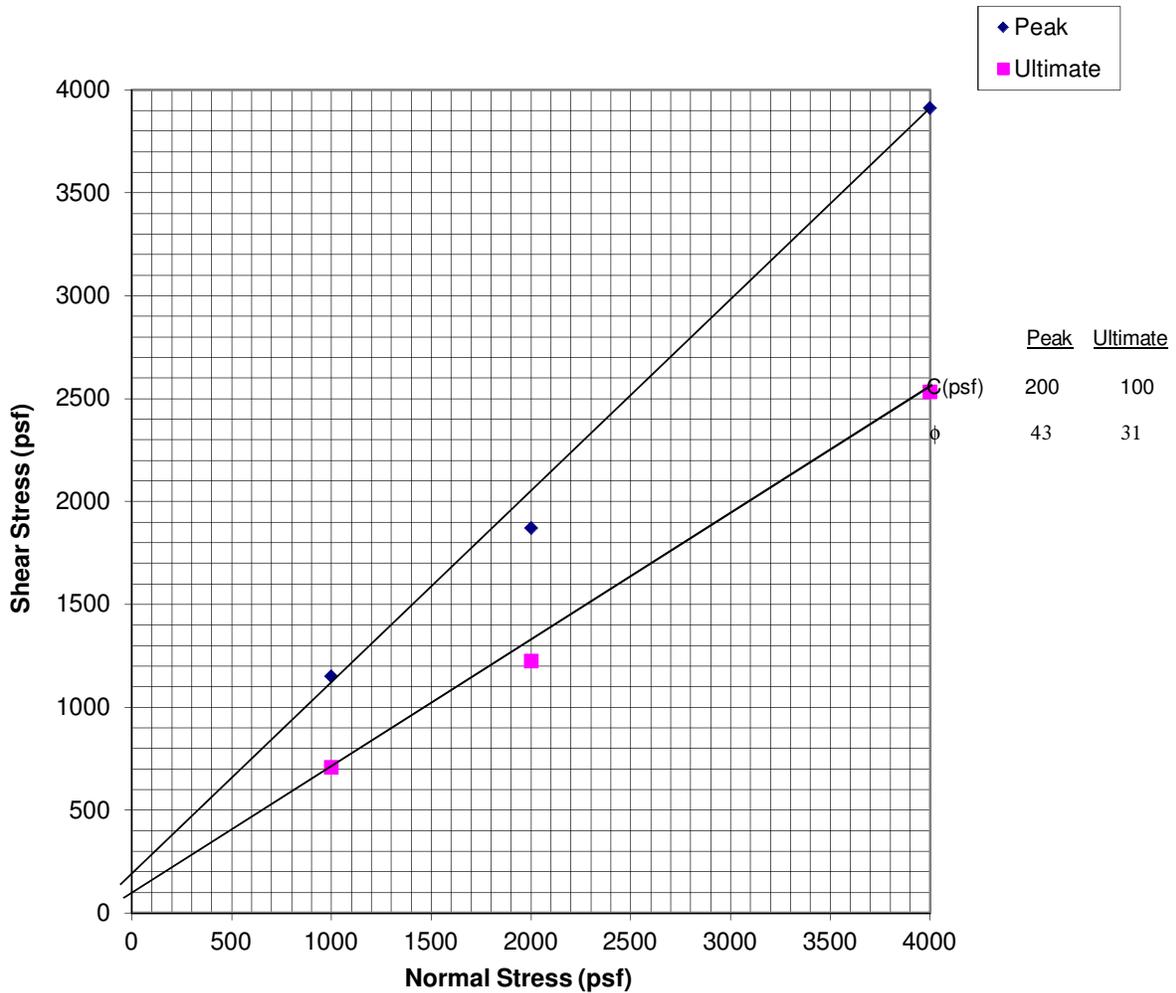
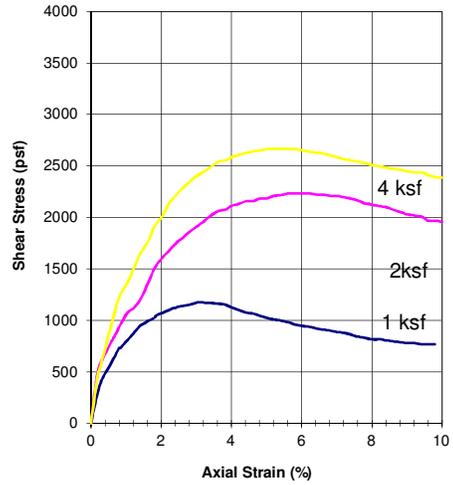
DIRECT SHEAR ASTM D3080

PROJECT: Langan # 700128701
 GLA JOB NO.: 2012-0057
 SAMPLE : LB-3 / S-2
 SAMPLE TYPE: Undisturbed
 DESCRIPTION: Silty Clay

Specimen No.	1	2	3
Normal Stress, psf	1000	2000	4000
Peak Stress, psf	1176	2232	2664
Displacement, % strain	3.04	5.6	5
Ultimate Stress, psf	756	1956	2388
Displacement, % strain	10	10	10
Initial Dry Density, pcf	116.2	116.2	116.2
Initial Water Content, %	15.2	15.2	15.2
Final Water Content, %	18.5	18.5	18.5
Strain Rate, in/min.	0.0084	0.0084	0.0084
