PRELIMINARY GEOTECHNICAL EVALUATION

Mill Creek Drive and Ridge Route Drive Laguna Hills, California

18 February 2026 (revised)
700128701

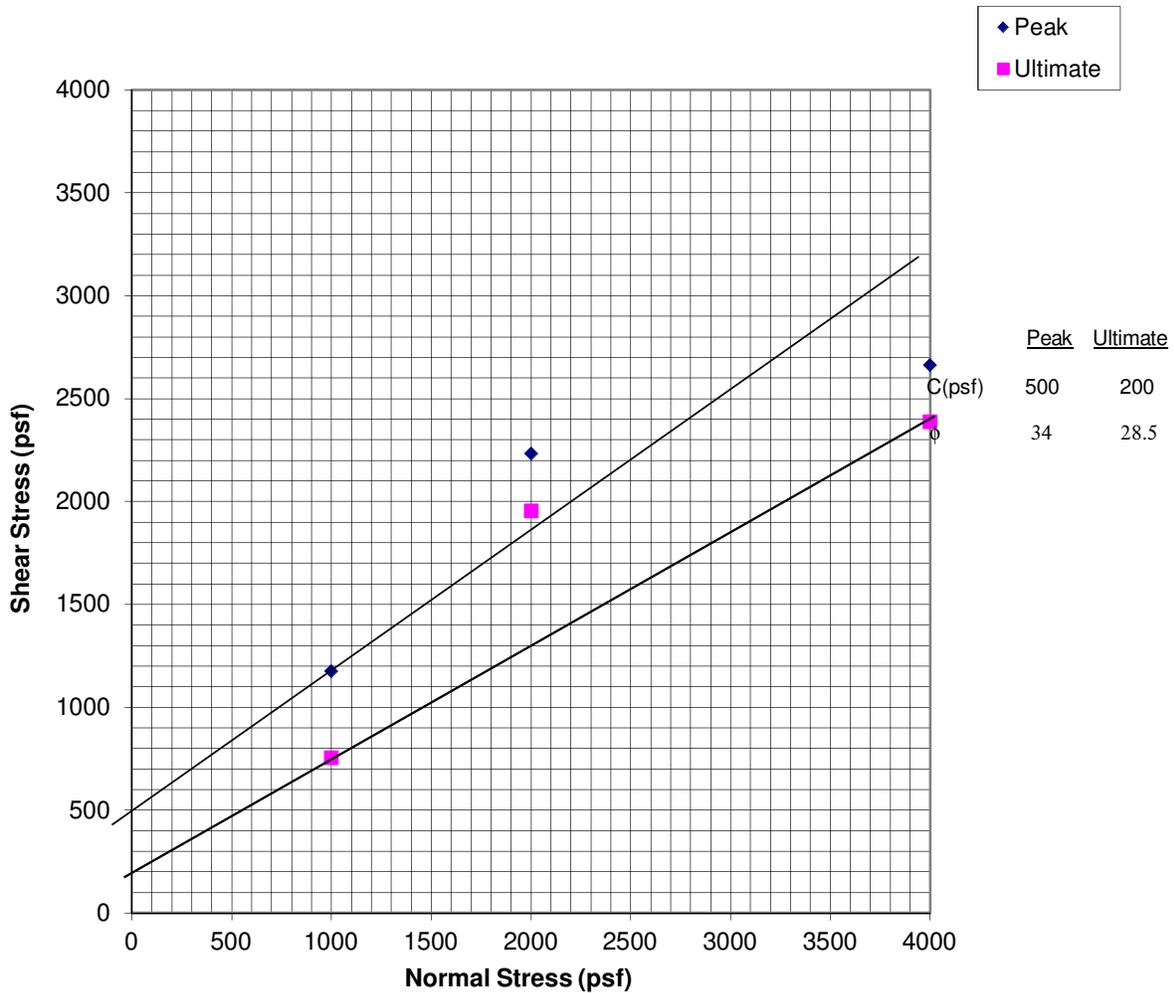
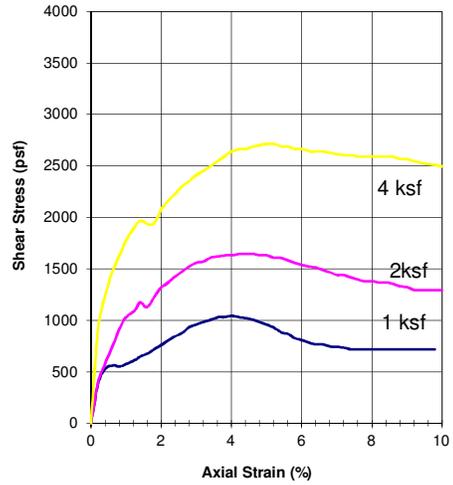
DIRECT SHEAR ASTM D3080

PROJECT: Langan # 700128701
 GLA JOB NO.: 2012-0057
 SAMPLE : LB-4 / S-1
 SAMPLE TYPE: Undisturbed
 DESCRIPTION: Silty Clay

Specimen No.	1	2	3
Normal Stress, psf	1000	2000	4000
Peak Stress, psf	1044	1644	2712
Displacement, % strain	4	4.2	5
Ultimate Stress, psf	720	1296	2508
Displacement, % strain	10	10	10
Initial Dry Density, pcf	114.3	114.3	114.3
Initial Water Content, %	15.2	15.2	15.2
Final Water Content, %	17.6	17.6	17.6
Strain Rate, in/min.	0.0084	0.0084	0.0084
